Attribution	British school, early 17 th century	RECORD No.
Subject	Portrait of a Man	2238
Collection	Cambridge, Clare College

EXAMINATION REPORT

TREATMENT REPORT

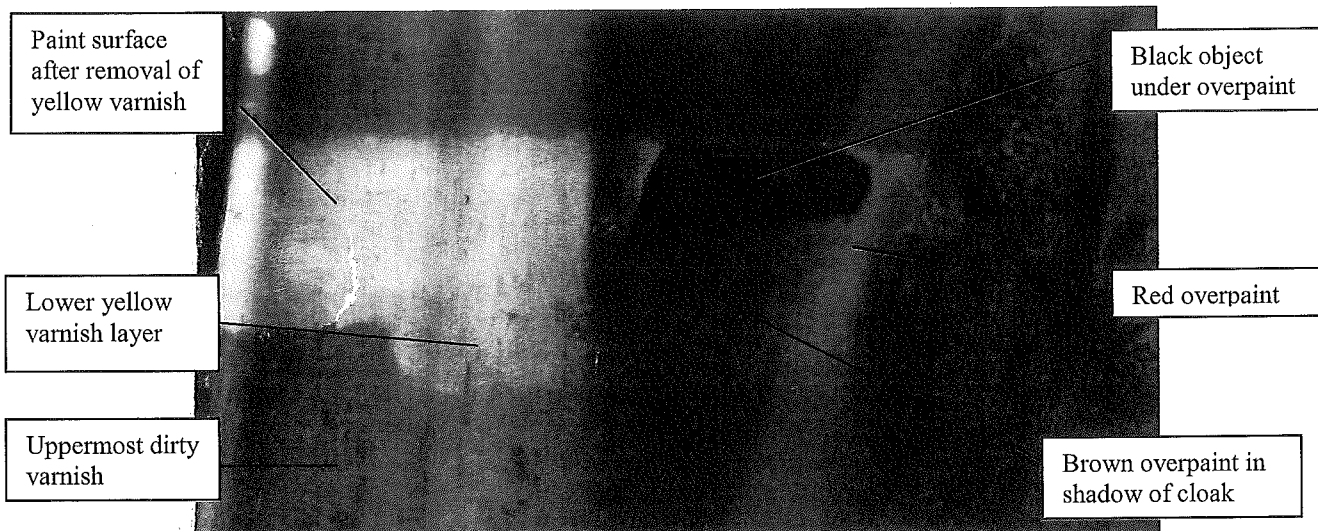
Varnish removal tests were carried out using a mixture of IMS and Shellsol T. An area of the white cloak at the left hand side of the image was chosen for the tests. A 1:8 ratio mixture was found to slowly remove the uppermost varnish layer and also brought away a large amount of dark material. From this it appears that the top varnish covers a layer of dirt. The removal of this dirty varnish resulted in a marked brightening of the colours and had a far greater cleaning effect than the surface cleaning had done. However, the surface was still yellowish in appearance and it was clear that another varnish was present beneath the top varnish and dirt layers. Further cleaning with the same solvent mixture removed this yellow varnish layer, revealing a truer picture of the colour beneath. The overall cleaning effect of removing both varnish layers was very marked, showing how obscured the image had been previously (see Figure 1, left).

The cleaning test was expanded into the area of shadow below the sitter's right arm, which revealed that this area had been extensively overpainted with brown paint. This paint was readily removed with the solvent, revealing a continuation of the grey shadow of the cloak. Extending the cleaning test still further uncovered an area of black paint with a curved boundary (see Figure 1, right). From this small uncovered area it appeared that some alteration had been made to the composition.

Figure 1. Area under right arm showing cleaning tests. On the left the marked effect of removing the varnish layers can be seen, while on the right the cleaning test is extended through the brown and red overpaint, revealing a dark shape underneath.

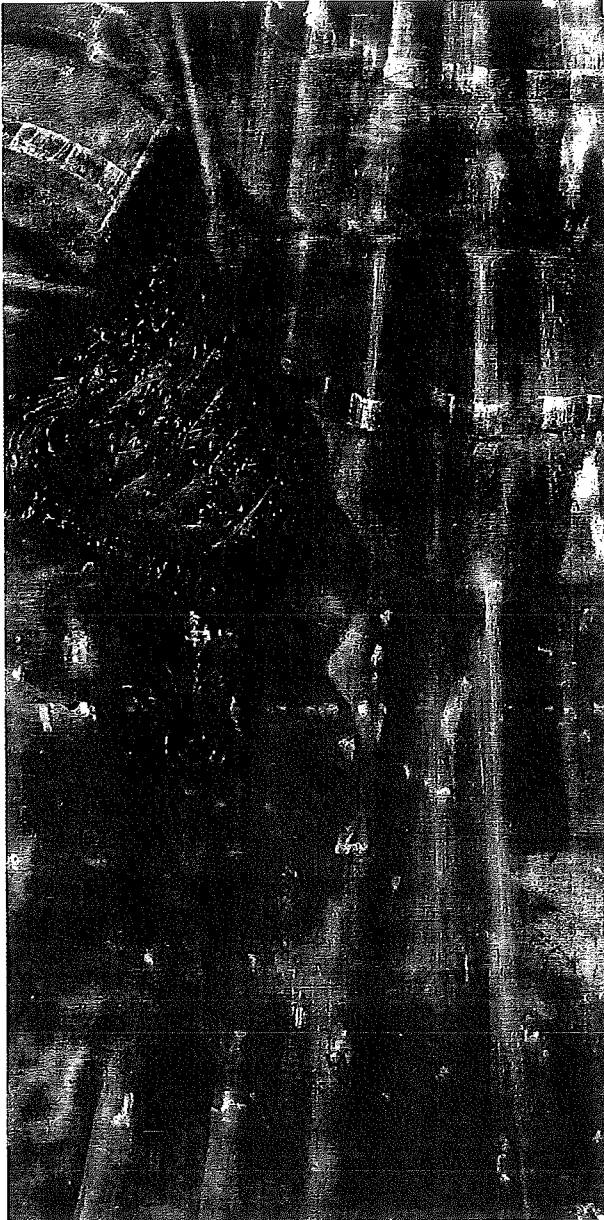
X-rays of the area revealed the same shape as observed under IR, but also showed a badge or medal of some kind was present on the black object (see Figure 2). The badge consists of a circular design topped with some plumes. The shape of the dark object suggests a hat, or possibly a purse or pouch. If this object does prove to be a hat, it is possible that the hat the sitter is wearing was added at the same time that this alteration was made, as it is unlikely for him to be carrying one hat and wearing another. Another point of interest is that the garter chain does not show up in the x-ray, while the decoration on the glove does. This shows that different pigments were used for the badge under the overpaint and glove decoration (probably lead-containing pigments) than for the garter chain.

In the x-ray several damages are visible in the area covered by the hat shape which cannot be detected from the surface in the overpaint. These damages must therefore be in the paint of the hat itself, and have subsequently been covered by the overpaint. This shows that the portrait had already suffered damage before the overpainting occurred, suggesting that this change was made some time after the portrait was finished.

Figure 2. X-radiograph of the left hand section of the painting, showing the outline of a rounded object under the gloved hand. A detail of the badge found on the object is shown above.

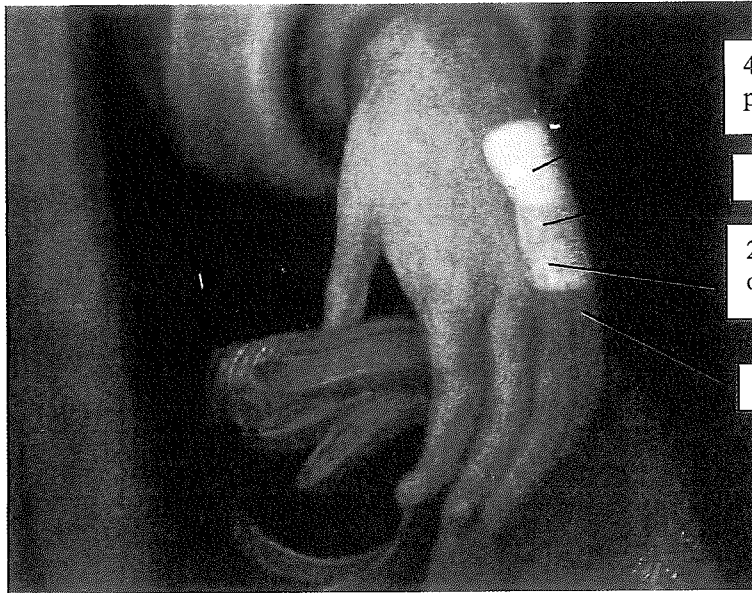
The sitter's left hand, which had previously been observed to have a wrinkled paint texture was also tested. This was found to have a readily soluble overpaint layer under the dirty varnish, underneath which was a yellow-brown varnish. Continuing the cleaning test through this second varnish layer revealed a paler flesh-coloured paint, which appeared to be in good condition despite the wholesale overpainting of this area (see Figure 3). It is possible that the hand was overpainted to disguise the extremely discoloured varnish coating, which gave the hand an orange appearance. This was probably an easier procedure than the removal of this discoloured coating.

4. Original flesh paint

3. Yellow varnish

2. Flesh-coloured overpaint

1. Dark varnish

Figure 3. Detail of sitter's left hand, with cleaning test showing painting layers (1= uppermost layer)

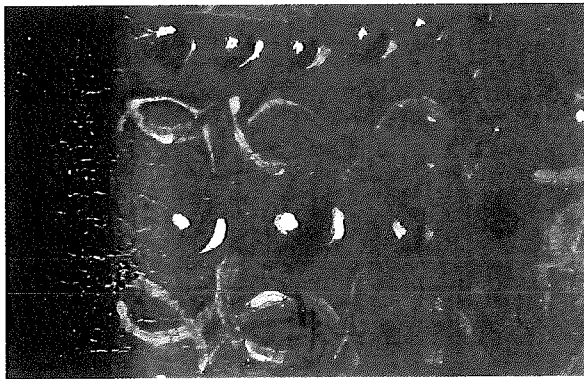
A cleaning test on the left glove decoration revealed the grey paint of the pearls to be readily soluble, while the lighter braiding and pearl highlights were stable. Closer examination of the grey paint of the pearls showed that they were painted on top of dark cracks in the red paint beneath (Figure 4). From this it was uncertain whether the glove decoration was also a later addition or whether the pearls had been strengthened during a previous restoration.

Figure 4. Detail of left glove decoration. The dark cracks in the red paint can be seen running underneath the translucent grey paint of the pearl

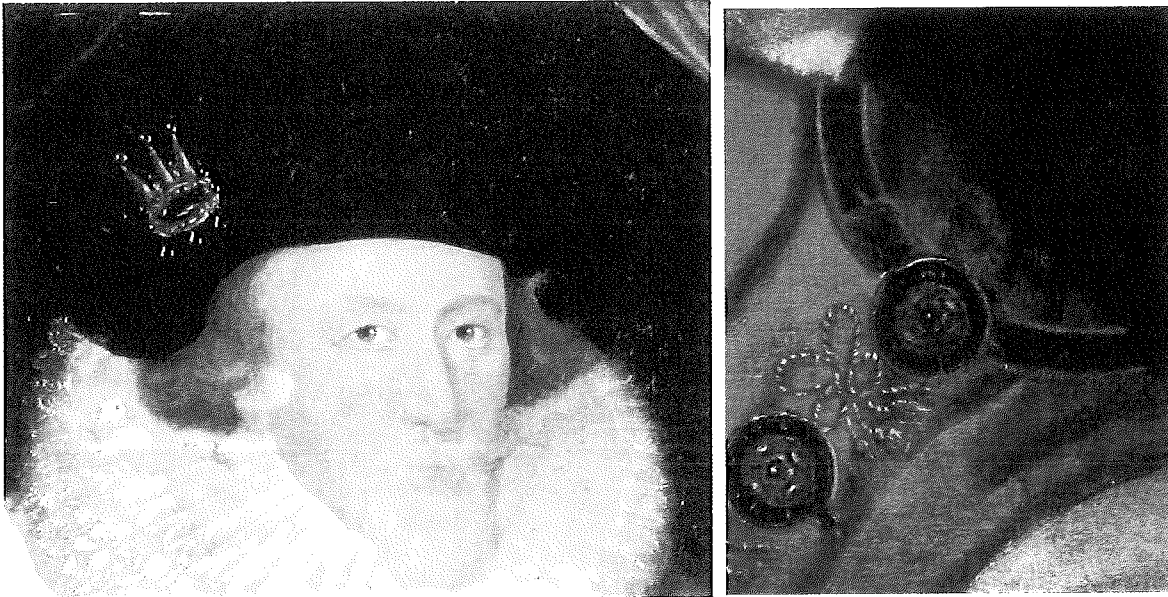
Removal of this very dark layer made it much easier to see the boundary between the original paint and the overpaint below the sitter's right arm. It also revealed some awkwardness in the way the additions were painted, making them seem of inferior quality to the original painting. For example on the left

shoulder a Garter motif appears which stops short of the edge of the shoulder and also bears little relation to the folds beneath. The hat on the head also appears unconvincing in the way the outline sits over his head and hair.

Figure 5. Details of hat and left shoulder after initial cleaning, showing how the additions appear to be painted with less care and skill than the original.

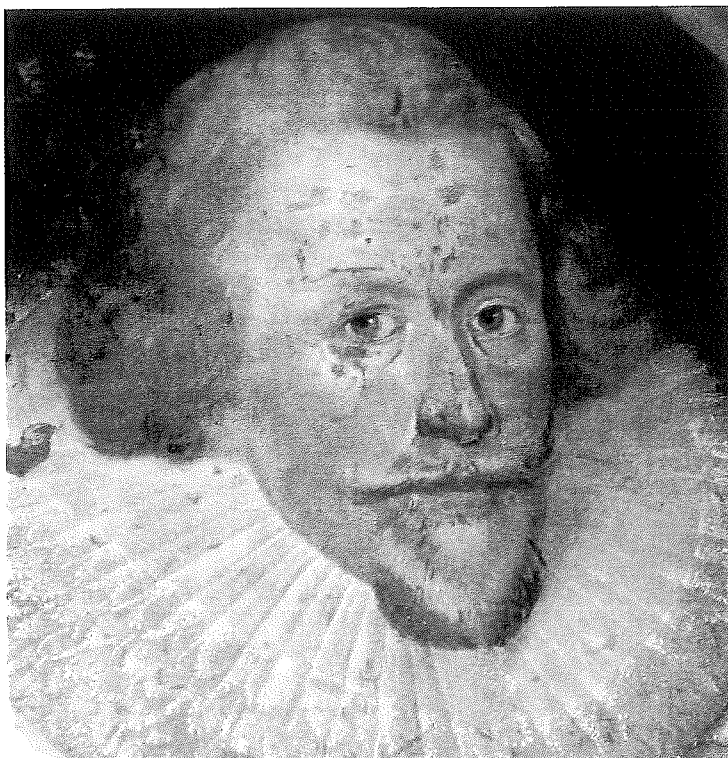
Examination of the portrait again in UV confirmed that further alterations had been made to the sitter's face. Strokes of repaint were clearly visible which had been used to change the shape of the beard and lengthen the moustache, covering the sitter's upper lip (see Figure 6). Spots of paint covering areas of abrasion on the face were also made visible. It is uncertain whether these changes resulted from the same campaign as the other alterations. If this is the case it is possible that they weren't removed during the previous cleaning step due to the higher lead white content of this overpaint, making it more stable than some of the other colours. This overpaint was removed using the Shellsol T/IMS mixture again in combination with some mechanical action from the glass engraving tool.

Figure 6
Detail of face in ultraviolet light showing alterations made to beard and moustache.
